### CALLEGUAS CREEK: PROBLEMS AND SOLUTIONS Prepared by Howard H. Chang, Ph.D., P.E. May 2006

#### I. OVERVIEW

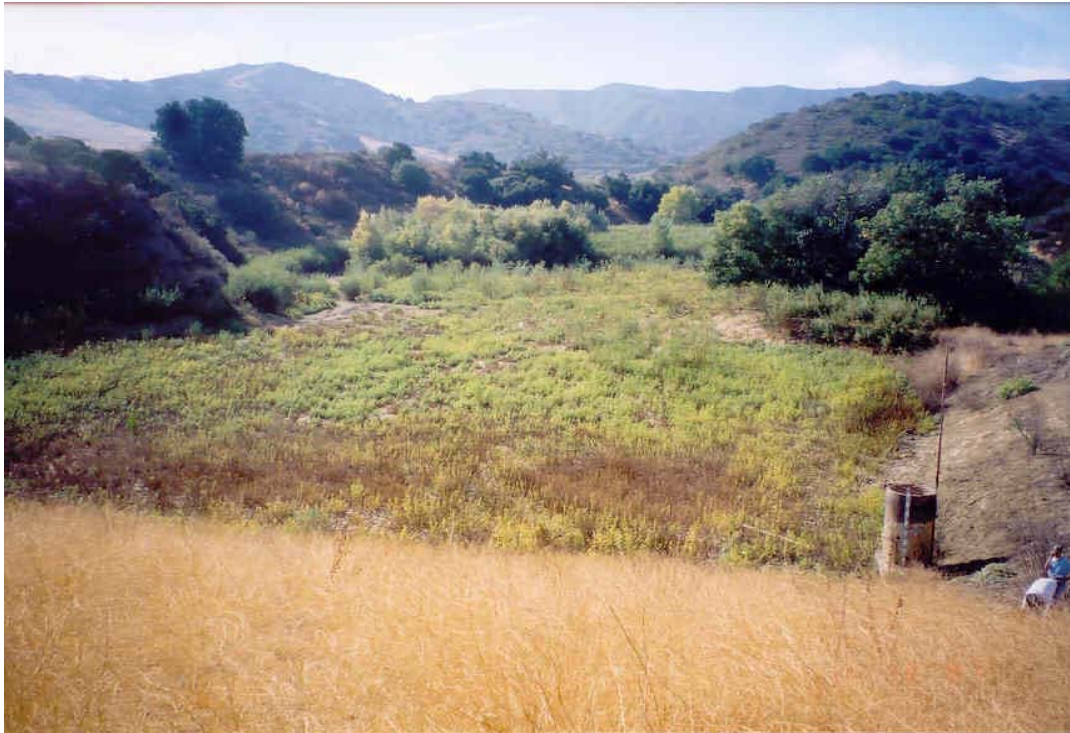
Degradation of the channel bed and erosion of the channel boundary along the upper channel reaches are caused a reduction of sediment supply from the watershed. Among the many factors, sediment basins should be the primary factor. Fig. 1 is a sediment basin on a tributary in Simi Valley. Sediment basins have trapped large amounts of sediment, preventing it from reaching Calleguas Creek. Channel bed degradation developed in responds to the deficit in sediment supply. In order to check channel bed degradation, a series of drop structures have been constructed along the channel. Degradation has continued, notably just below the drop structure below Hitch Boulevard.

Fig. 1. View of a sediment basin on a tributary of Arroyo Simi
